PERFORMANCE EVALUATION OF EXISTING BUILDINGS IN THE AUGUST 24, 2016 CENTRAL ITALY EARTHQUAKE

MARIA HELENA PAIXÃO COSTA

Dissertação submetida para satisfação parcial dos requisitos do grau de
MESTRE EM ENGENHARIA CIVIL — ESPECIALIZAÇÃO EM ESTRUTURAS

JUNHO DE 2017

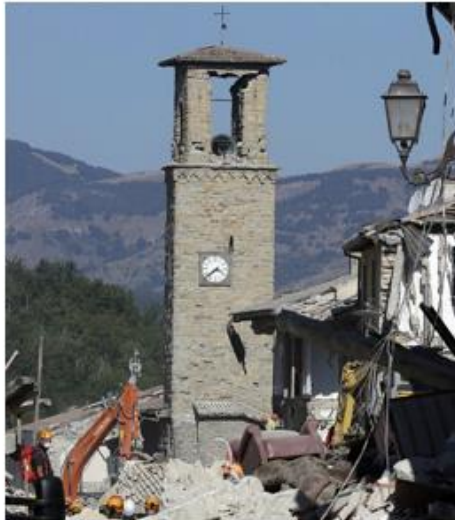
By contrast, the 16th century bell tower remains standing and its clock froze at just 03:36, the moment the earthquake hit the town figure 2.9. In Norcia, the 14th century San Benedetto basilica partially collapsed during the 30th October, figure 2.13.

Figure 2.9-Bell tower showing the exact time of the catastrophe, 03:36

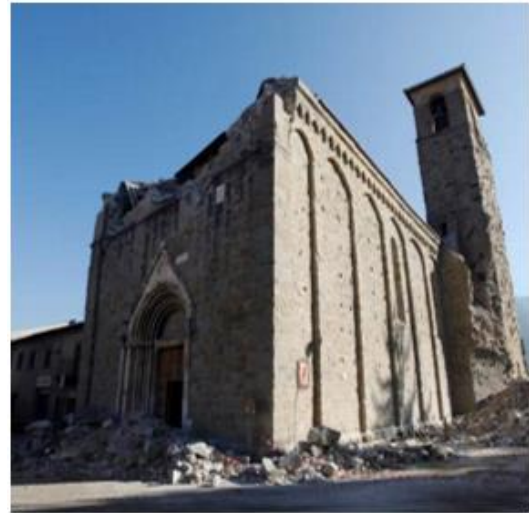
In Amatrice, half the façade of the 15th century church of Sant'Agostino has collapsed, figure 2.10, as well as other churches like Santa Maria del Suffragio, figure 2.14, and one museum. In the near villages like Accumoli similarly other churches suffered severe damage like the case of San Giovanni, where one load bearing wall partially collapsed, figure 2.11, and in the centre, part of the façade of the church disappeared figure 2.12.

Figure 2.10-Sant'Agostino church with its tympanum collapsed

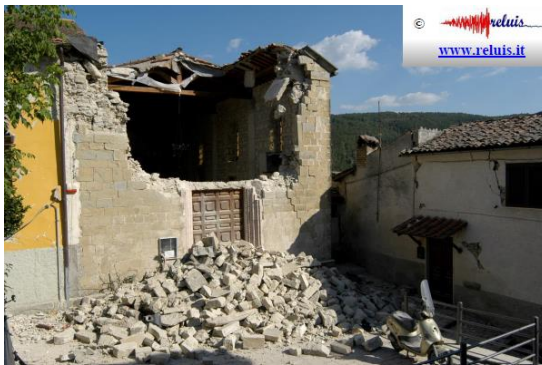
Figure 2.12-Collapse of a masonry church, Accumoli

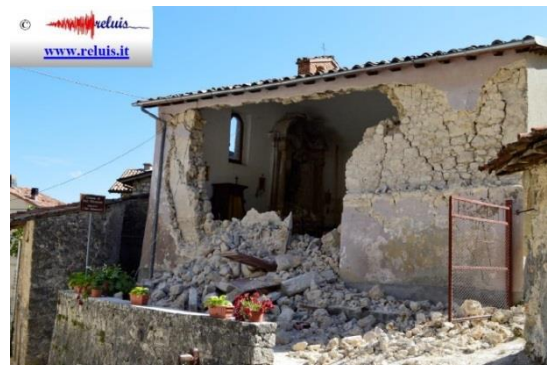
Figure 2.11-Collapse of San Giovanni church, Accumoli

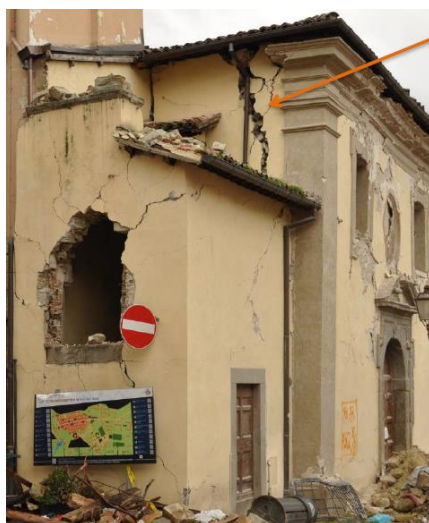
Figure 2.14 -Church Santa Maria del Suffragio, Amatrice red zone

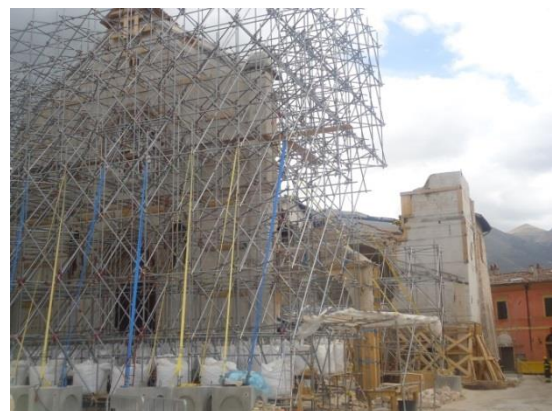
Figure 2.13-Church San Benedetto, Norcia after the October 30, 2016

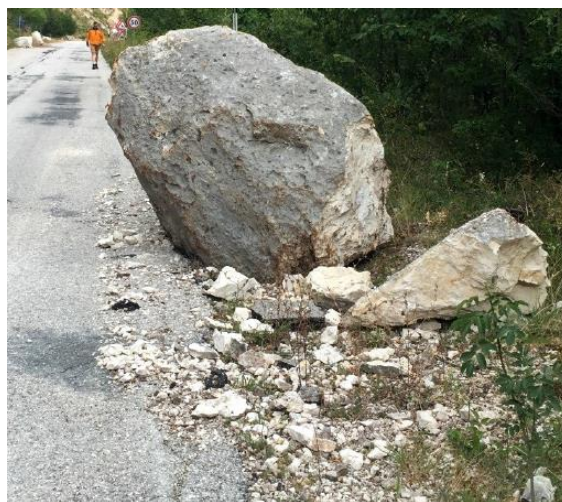
Figure 2.16 -Rock fall on SP477. The block is 2 meters unit of limestone that desegregated from the bedrock

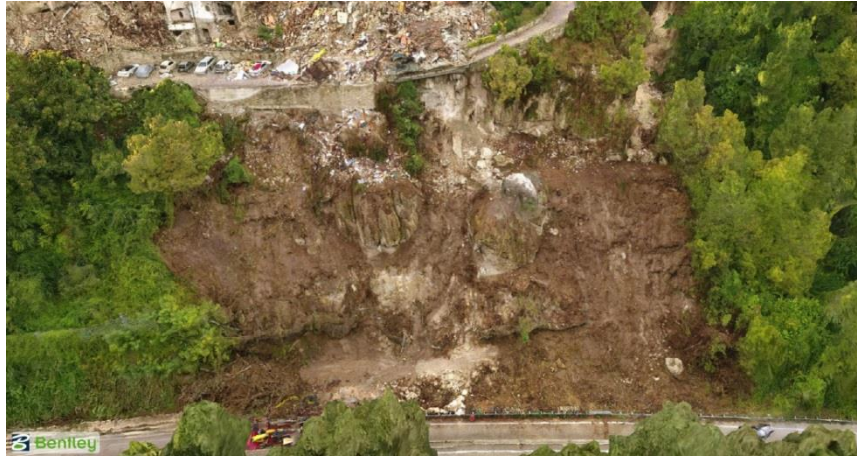
Pescara del Tronto was one of the villages that suffered more landslides and retaining wall failures, including the largest landslide that happened on the east zone figures 2.17-2.18. The landslide itself was shallow, being the width of sliding soil less than one meter.

Figure 2.18-3D model image of largest landslide in Pescara del Tronto, in the east part (source GEER). It is about 30 meters high and 75 meters wide

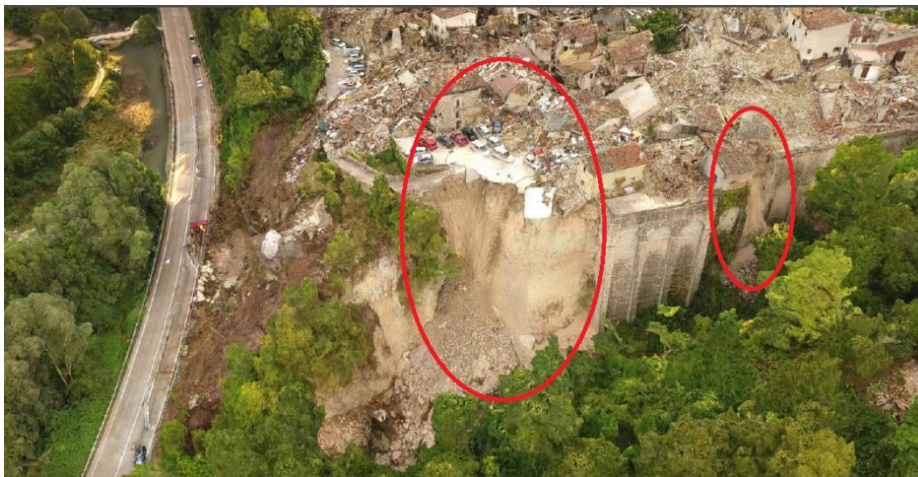
Figure 2.19-3D model image of two slope failures near the largest one, Pescara del Tronto (source GEER) .

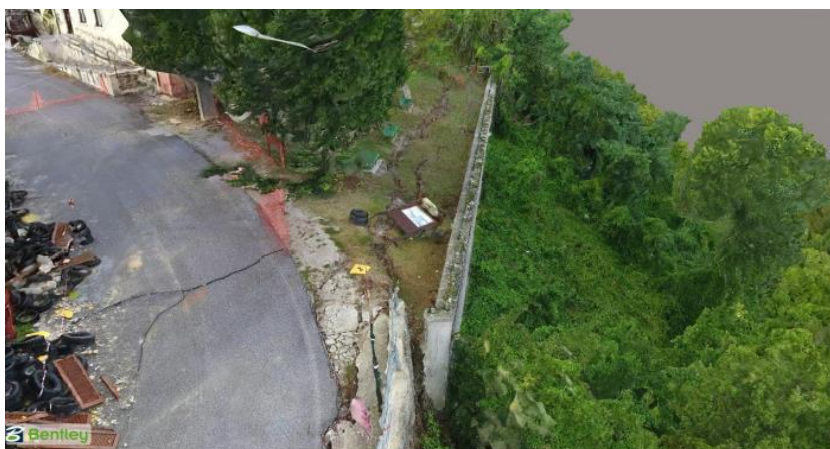
Regarding the damage observed in Accumoli, the instabilities were mainly significant deformation and cracking in the soil, in the eastern area and no landslides were reported. Figure 2.20 exhibits a cracking pattern that, at first sight, seemed due to a landslide but later was found to be the result of a retaining wall failure. The concrete wall rotated 3.5 degrees, with a horizontal offset of 57 cm and vertical offset of 18cm. The soil graben measured 2.7 meters wide and the soil settled approximately 50cm.

Figure 2.20-Retaining wall failure and rotation of the concrete wall causing significant cracking in the soil immediately behind (graben), (source GEER)

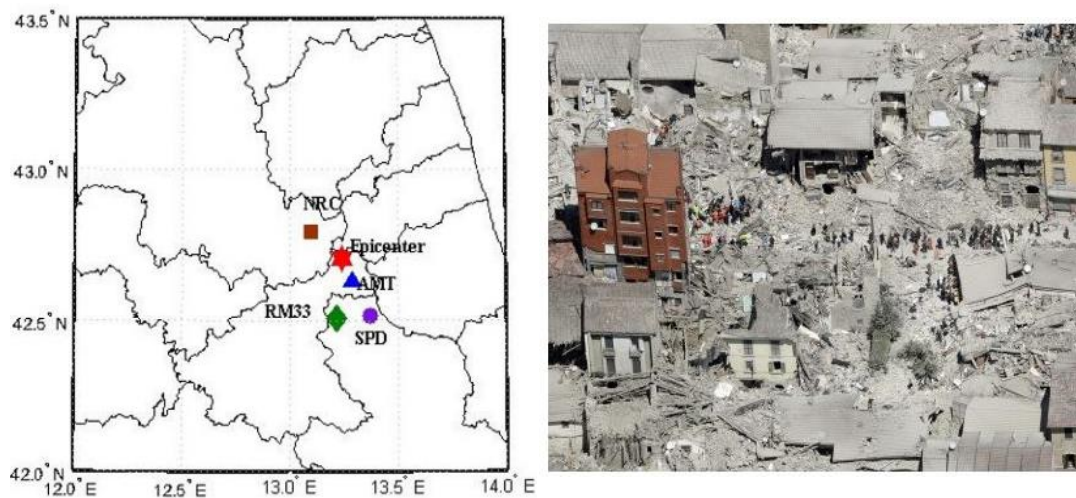
From the observation of the spectrums it can be concluded that the higher accelerations are in the range of 0.2-0.3s, in relation to other periods. This range corresponds, grossly, to rigid structures (typically low structures) consistent with most of the built in Amatrice and small villages, which could explain their severe damage. To corroborate this theory, there is the example of one high and flexible reinforced

concrete building in Amatrice centre that remained standing, while the surrounding structures are destroyed, because of its higher period, 0.4-1.0s, corresponding to lower accelerations values. Unfortunately, this building did not resist the second main earthquake in 26th October due to its significant level of damage.

Figure 2.27 -From left to right: map of the four stations with lowest epicentral distance. On the right, standing reinforced concrete building in Amatrice centre

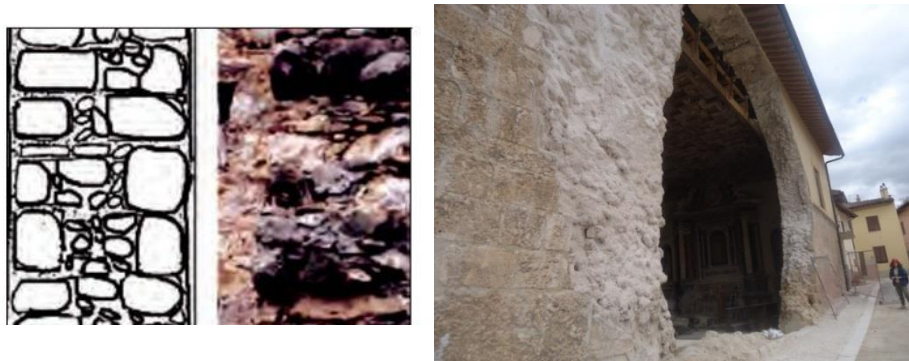
It is worth mentioning that some textures may seem regular from the outside but, in reality, the interior does not correspond to the exterior. Is this the case of a church in Norcia that collapsed during the 30th October event, figure 3.9 right. The masonry wall corresponds to a three-leaf wall, made by regular big stones in the exterior leaves and, the inside leaf seems limestone. Therefore, a precise investigation of the mechanical behaviour of masonry walls, especially in multi-leaf walls case, is important to understand their seismic performance.

Lateral view of *muratura a sacco* figure 3.9 left where is visible the different stone sizes in a double leaf wall filled with rubble, smaller masonry particles, badly connected to the leaves.

Figure 3.8 -From left to right: lateral view of masonry *muratura a sacco* and on the right, Norcia's collapsed church with different masonry in the inside leaf

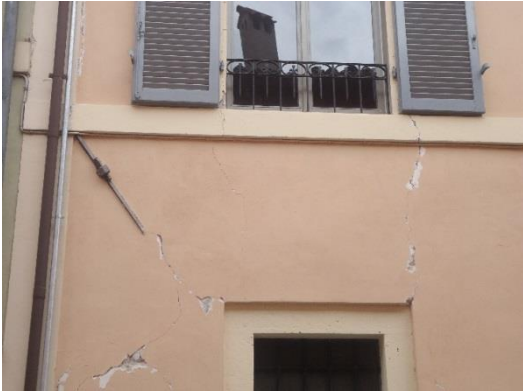
Figure 3.12 -Type 1: the vertical cracks from the two openings are connected, Norcia

Flexural crack type 5 is relevant and it is probable that in case of aftershocks the damage is much more severe. Regarding the flexural crack type 1, when the damage is restricted the structural risk may be low but, if on the contrary, it is possible that many of the spandrel beams are not able to constrain the masonry piers anymore, the structural risk is high.

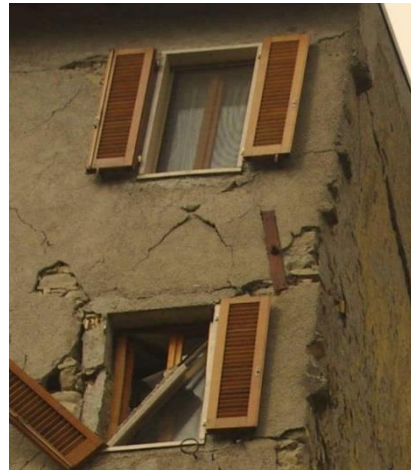
Figure 3.13 -Type 2, Arquata del Tronto

Diagonal shear cracking type 2 and 3 are due to the trigger of a shear resistant mechanism inducing the visible displacements. If the displacements are low and restricted, the structural risk is declared low. However, if the displacements are significant the risk for the building is high. In figure 3.16, shear cracking in the corner is close to the partial collapse. Often, this typology of cracking leads to the trigger of a complex mechanism, including out of plane bending of the walls panels. The bending is well visible in these cases and the partial collapse is likely to happen.

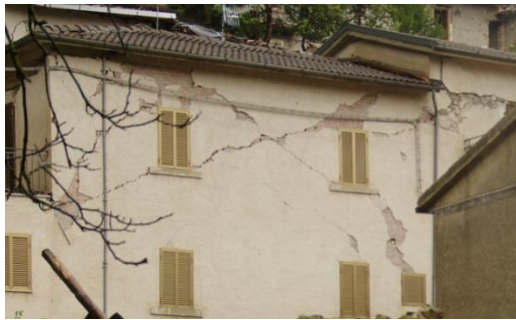
Figure 3.14 -Type 3: X shaped cracks between openings, Pescara del Tronto

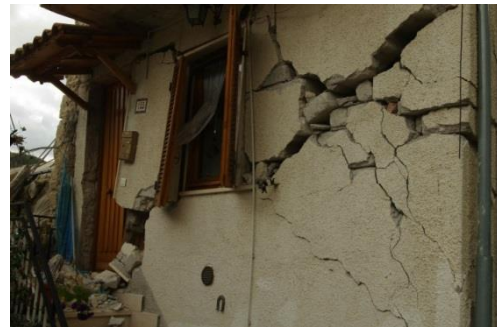
Figure 3.15 -Type 3: X shaped cracks between the opening and the corner, Arquata del Tronto

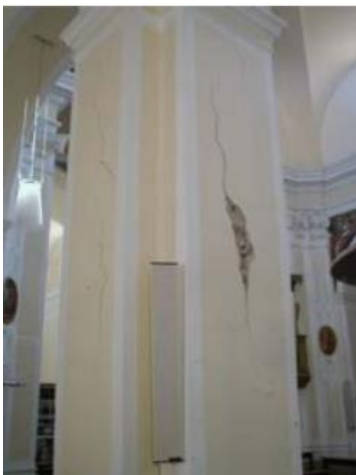
Figure 3.16 -Type 4: localized expulsion of material in a church's column due to the overcome of the compression strenght

Cracking of type 4, might be an indication of crushing failures. The performance of the masonry towards this failure mechanism is usually brittle, especially in solid brick masonry and hollow brick masonry. The risk which this type of cracking carries depends on the wall geometry and typology and extension of the damage, which specifies how much the vertical bearing resistance is affected. If a high concentration vertical stresses happened (result from the presence of openings that diminishes the load bearing system, for example) the structural risk is declared high, mainly in buildings with poor quality masonry and lack of maintenance.

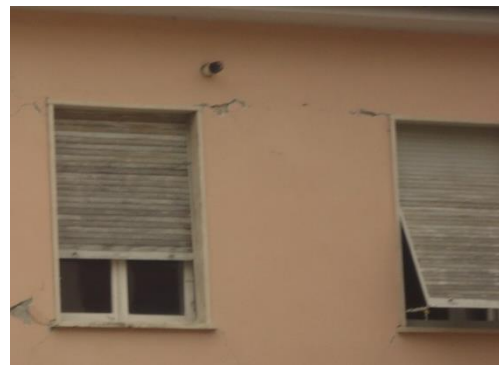
Figure 3.17 -Type 5, flexural cracks with slight detachment of the plaster on the corners, Norcia

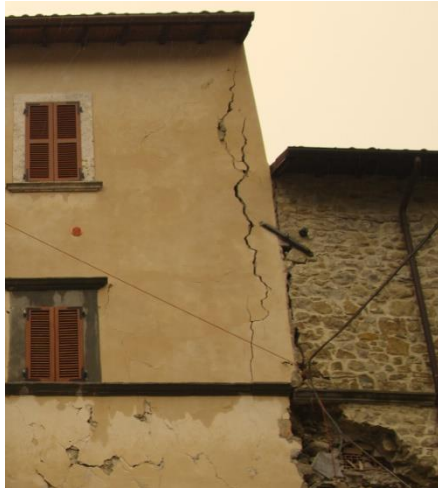
Figure 3.18 -Type 7: vertical cracks along the intersection between buildings evidencing the trigger of out of plane mechanisms, Arquata del Tronto

Vertical cracks in the intersections between orthogonal walls, type 7, are the proof of lack of connections between the referred walls and the original structural configuration has been changed. Cases like these need careful attention when evaluating the structural risk, because in case of aftershocks the activation of an out of plane mechanism is probable. Type 6 is similar to type 7 only with the difference that in this case the cracking is not through the masonry wall.

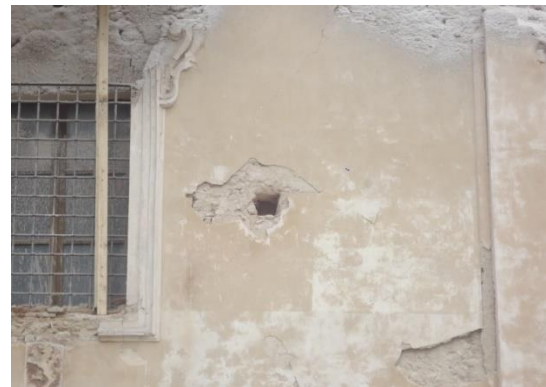
Figure 3.19-Type 8, Norcia

Type 8 cracking should be declared as high structural risk if there is a decrease of the load bearing capacity, usually connected to out of plumb result of pounding actions. In the picture, this failure occurred allied to others more complex.

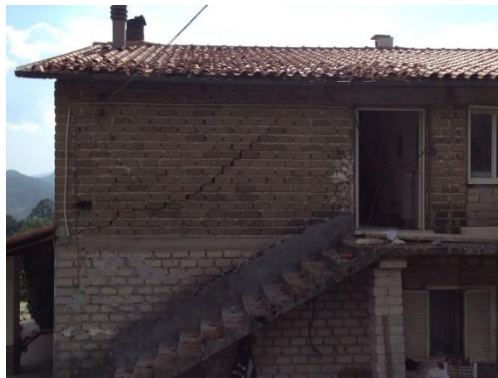
Figure 3.20 -Type 9, Accumoli

Type 9 cracks are clearly detected when there is the separation of the wedges of the masonry building. If this separation involves significant displacements the structural risk is high.

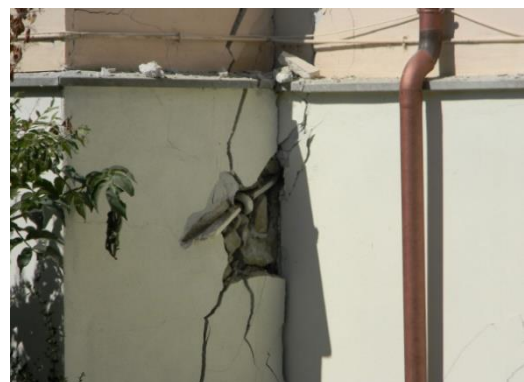
Figure 3.21-Type 10, Accumoli

Type 10 failure consists in tie failures or bond slippage with out of plumb related. The high structural risk of tie failures is associated to the consequences on the masonry building the modification of the static configuration carries.

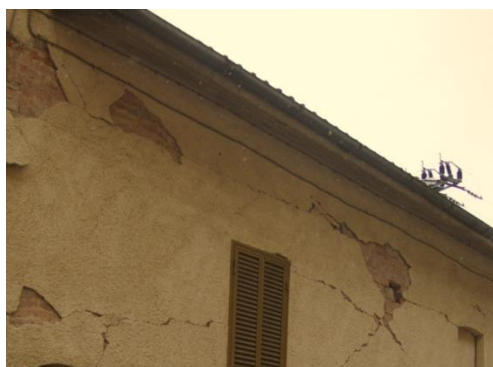
Figure 3.22 -Type 11: horizontal crack corresponding to the slab roof/floor, Pescara del Tronto

A type 11 crack with displacements of mm is the sign of sliding between the floors level and the masonry wall underneath. The most common case of sliding is between the roof and the masonry walls. This effect is due to the thrusting roofs and it is possible to carry a high structural risk, result of the combination between thrusting roofs and the alteration introduced by the sliding.

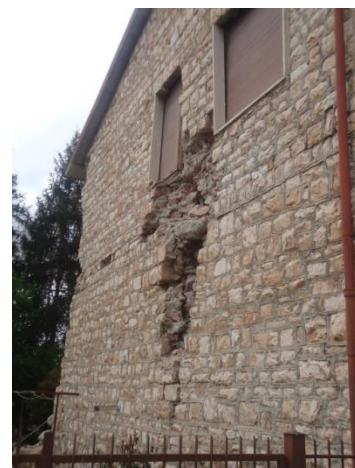
Figure 3.23 -Type 12: localized detachment of the external leaf in the centre of the panel, Norcia

Indications of out of plumb are usually connected to cracks type 6 and type 7, with probable disaggregation between the walls and floors, and the structural risk generally associated is high. When this phenomenon is visually evident it is necessary attention: if the masonry wall configuration is a double-leaf (section 3.1.1.2) or *sacco* (section 3.1.1.3) it is likely to occur separation between leaves. In these cases, type 12 cracks appear.

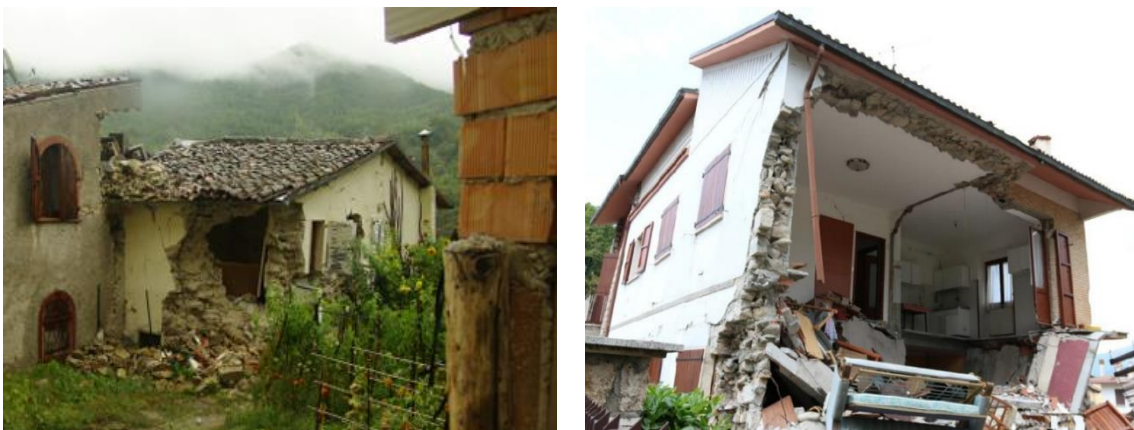
Figure 3.30 -Composite overturning (one side wing) in Pescara del Tronto and Amatrice

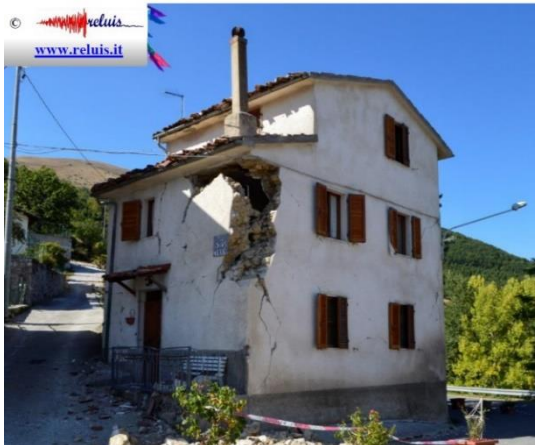
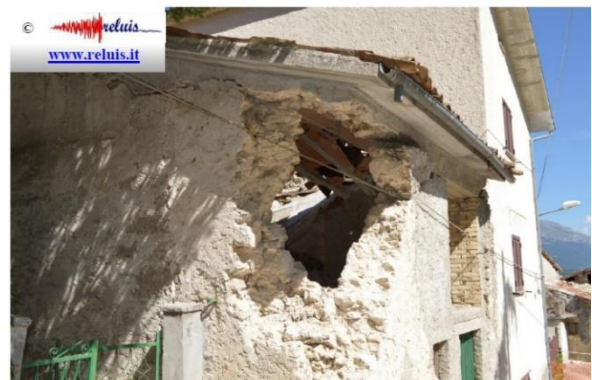
Figure 3.32 -From left to right: corner failure, probably exacerbated by the presence of a chimney which contributed to the high thrusts coming from the roof, Accumoli. On the right: Corner failure in a hip roof, demonstrating the triangular collapse surface, Accumoli

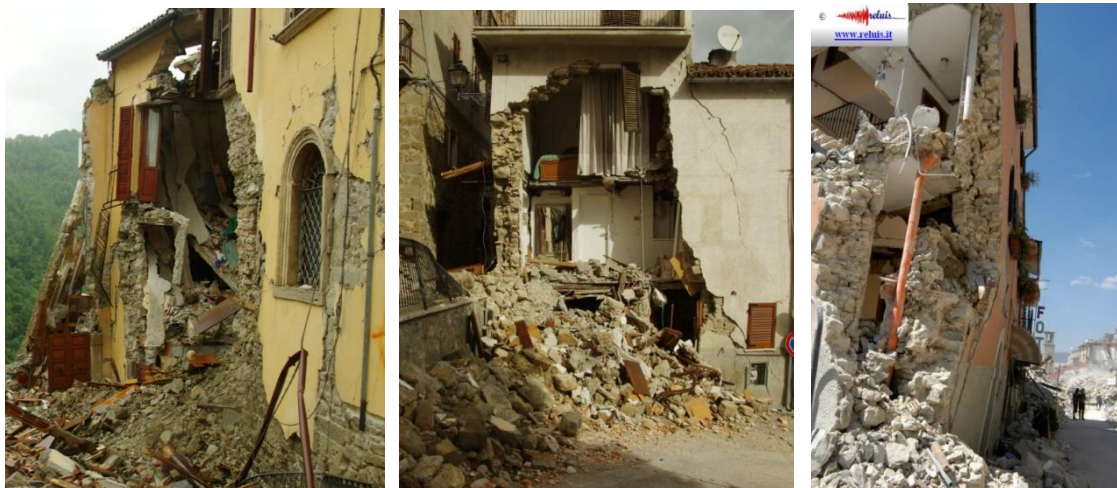
Figure 3.34 -From left to right: vertical bending involving one floor, vertical bending involving two floors, Arquata de l Tronto and relevant out of plumb showing signs of an incipient vertical bending, Amatrice

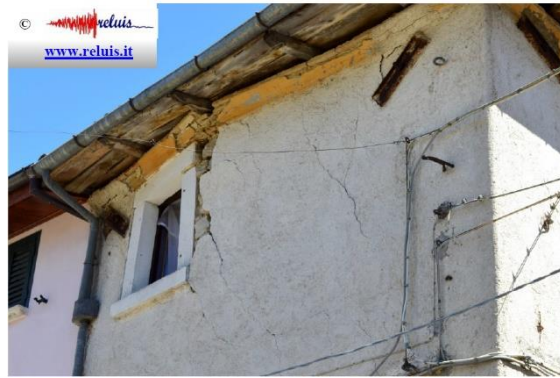
Figure 3.37- Evident out of plumb revealing the horizontal bending, Scaia, Amatrice. The tie beams visible in the picture were not capable of avoiding the triggering of the mechanism

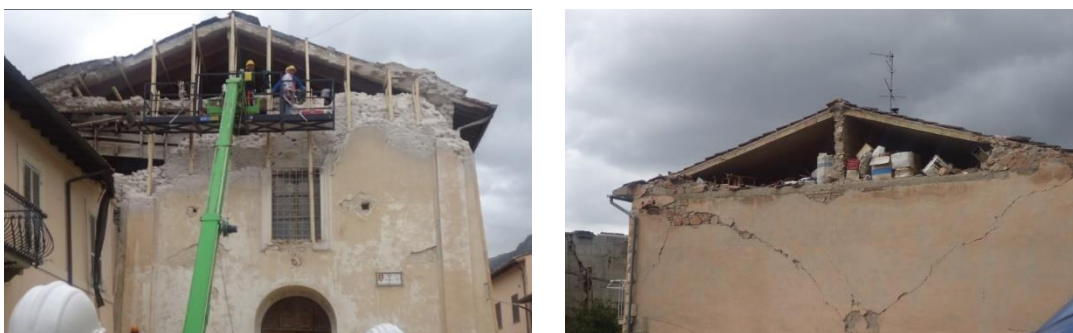
Figure 3.39-From left to right: tympanum collapse of a church and start of its reconstruction. On the right, tympanum collapse of a residential building, Norcia

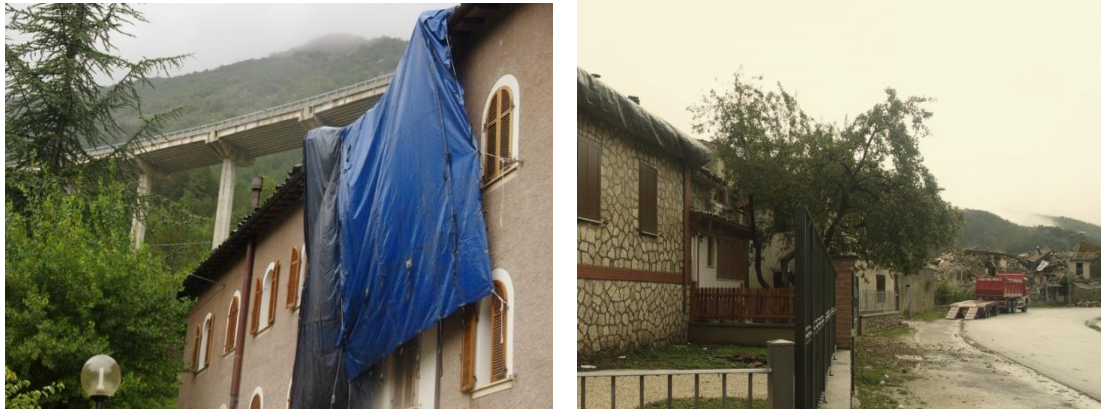
Roof collapse is common during the occurrence of earthquakes and is one of the most fatal mechanisms. It can take place when either the walls lose the ability to resist gravity loads and collapse, or when the roof structure collapses. The latter case is often caused by inadequate wall-to-roof connection: the roof structure can simply move out from the walls and cave into the building.

Figure 3.40-Roof collapse, from left to right: Pescara del Tronto and Arquata del Tronto

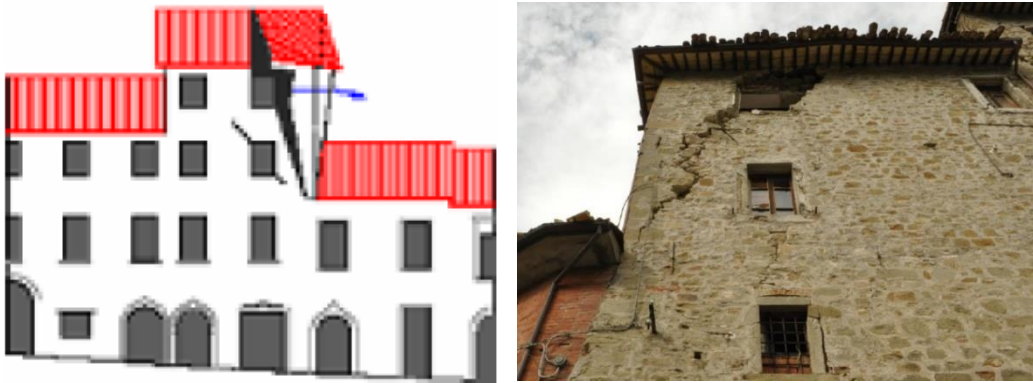
Figure 3.42 -From left to right: Schematic model of an overturning wall due to hammering and a real case of pounding in Arquata del Tronto, 2016

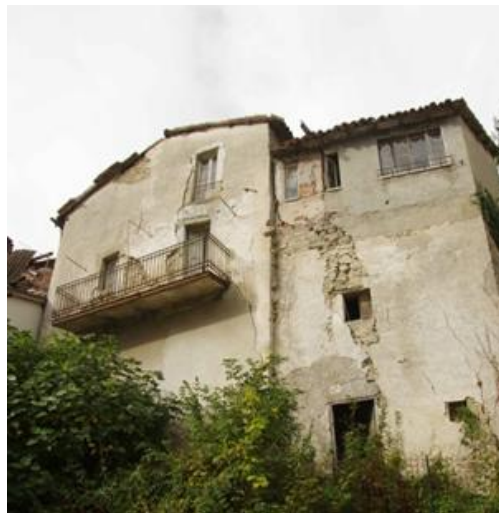
Figure 3.43 -In this case the overturning of the wall does not occur, only cracks in the intersection between the two buildings, Amatrice, 2016

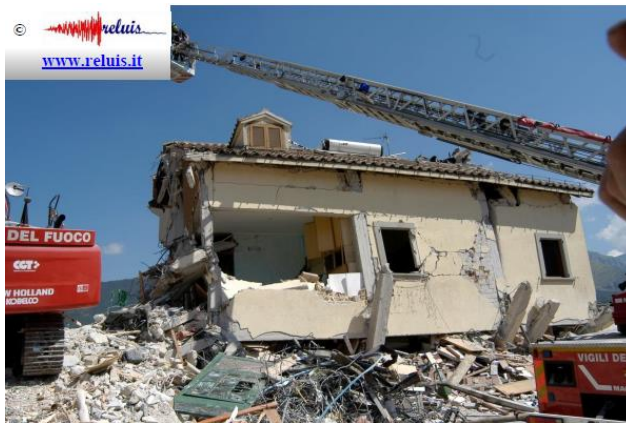
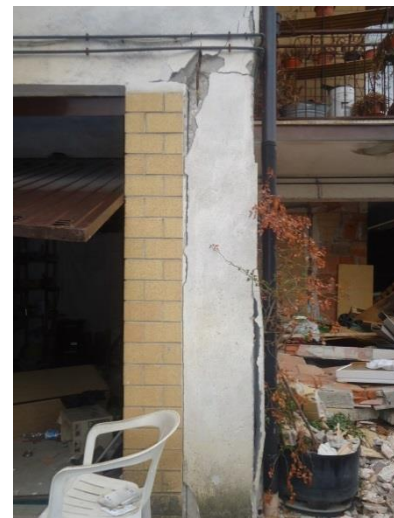
Figure 3.47-From left to right: evident soft storey mechanism of the Hotel Roma, Amatrice. The lack of stirrups and the use of smooth bars facilitated the mechanism. On the right, incipient soft storey mechanism revealed by the separation between the concrete column. Also the coatings buckling reveals this mechanism. In the joint is visible lack of transverse reinforcement, Norcia

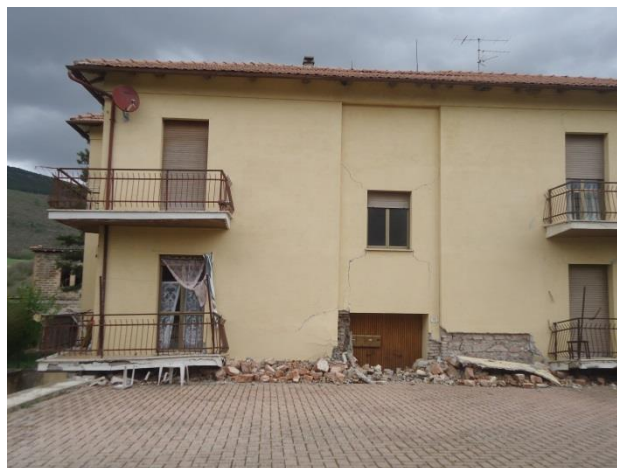
Figure 3.48 -In this case the soft storey occurred in a masonry building: the first floor completely disappeared and the second and third floors remained standing, Norcia

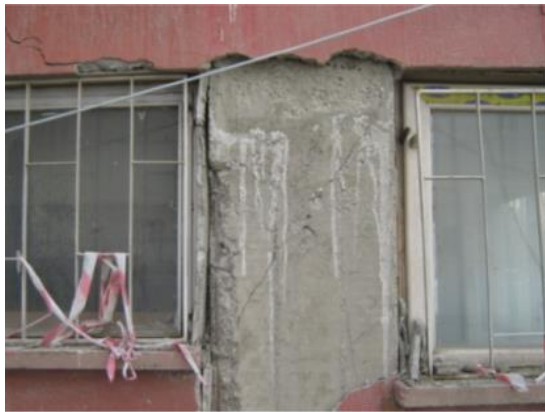
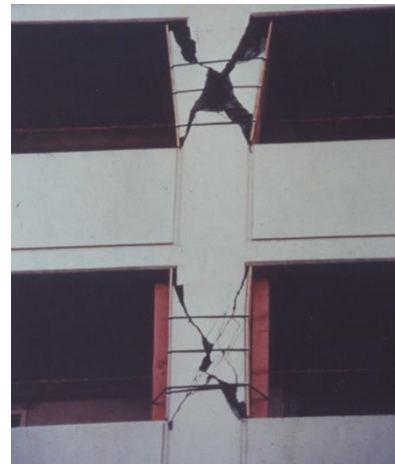
Figure 3.50-Columns shortened by the presence of openings with visible X-shaped shear cracking. From left to right: Turkey, 2011 and United States of America, 1994

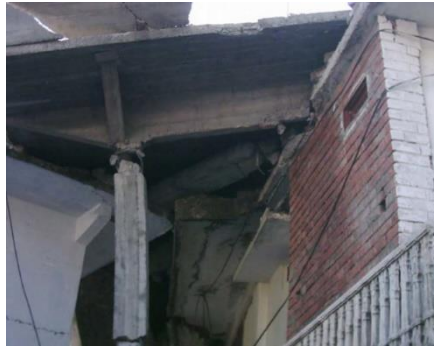
Figure 3.53-Plastic hinge formed in the beam column joint. From the observation, it is obvious the fragility of the column compared with the monumental slab it was supporting, Pakistan, 2005

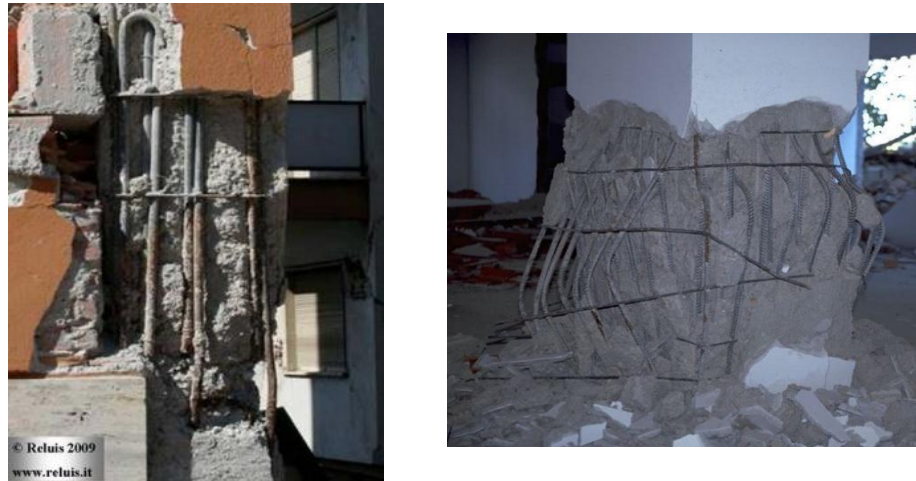
Figure 3.55-Inadequate lap-slices and lack of stirrups in both figures. From left to right: lap-slices done in a sensitive zone and plane reinforcement bars diminishing the friction between them and concrete, Italy 2009. On the right: lap-slices appear in the end of columns, the zone of the first plastic hinges, Turkey, 1999

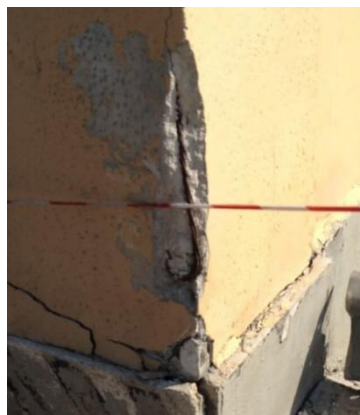
Figure 3.56.1-In this case of the hospital in Amatrice the anchorage of the steel reinforcement seems to have been done before the end of the pier

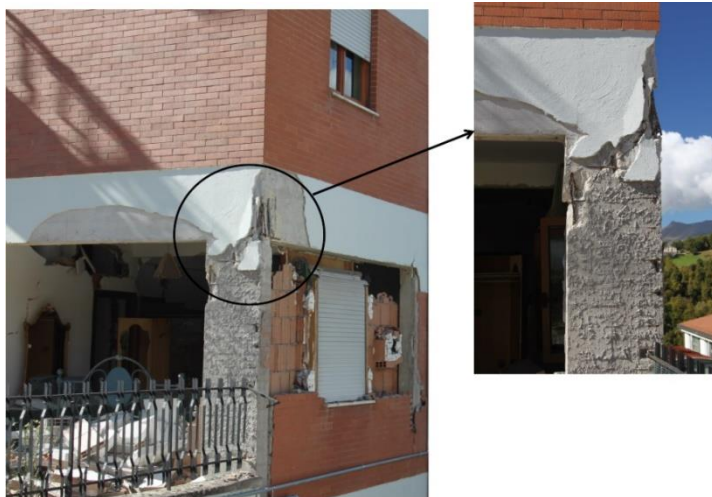
Figure 3.57-Shear failure of a corner column in a five-storey building accompanied by damage in the beam-column joint. The buckling of the longitudinal reinforcement is visible. Once again, the importance of detailing, bars anchorage and shear strength, Amatrice

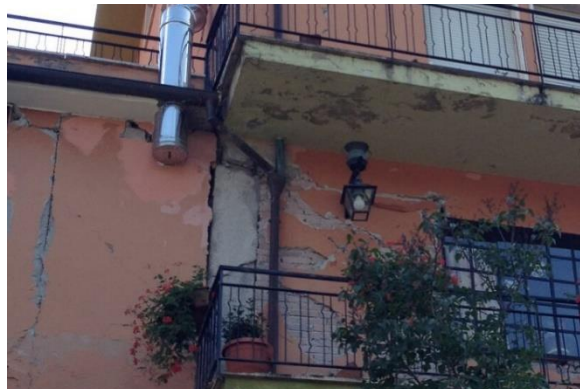
Figure 3.58 -Shear failure of the concrete column due to the shear action of the masonry panels, Norcia

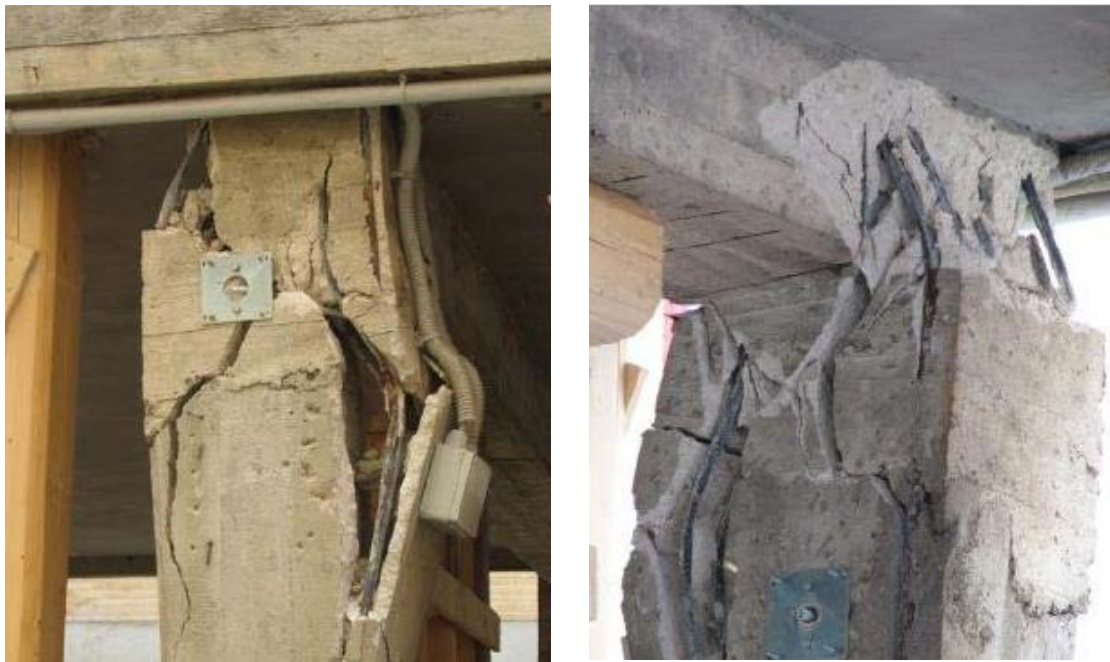
Figure 3.59-Flexural deficient behaviour in reinforced concrete columns. On top San Salvatore Hospital, Italy, 2009. On the left, front view and on the right, back view.

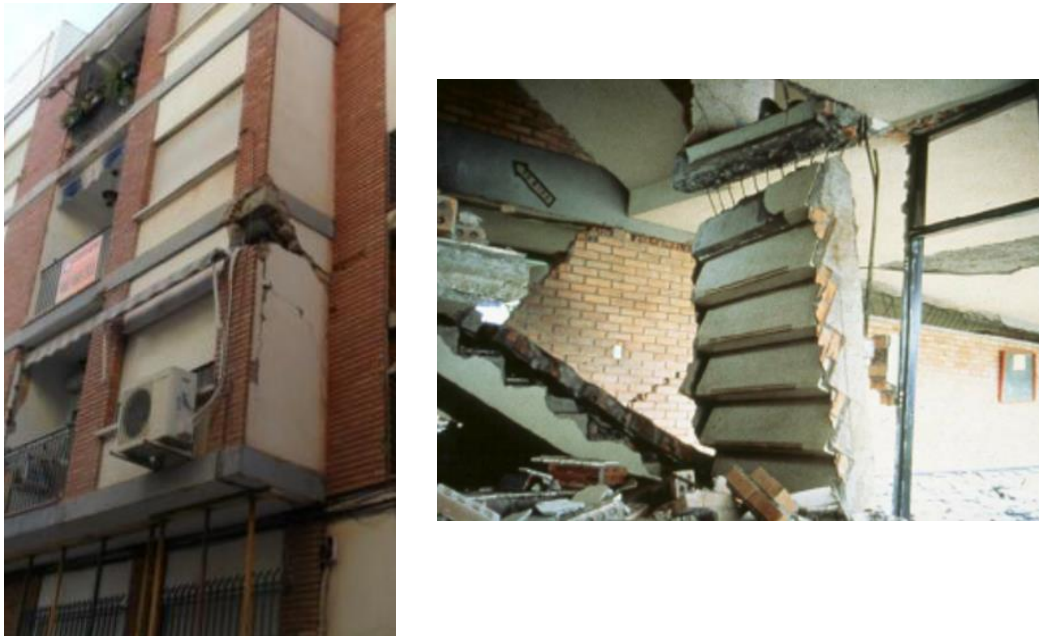
Figure 3.61 -From left to right: excessive deformation in a cantilever, also due to the vertical seismic component. On the right, total collapse of the stairs in the first floor. Spain 2011

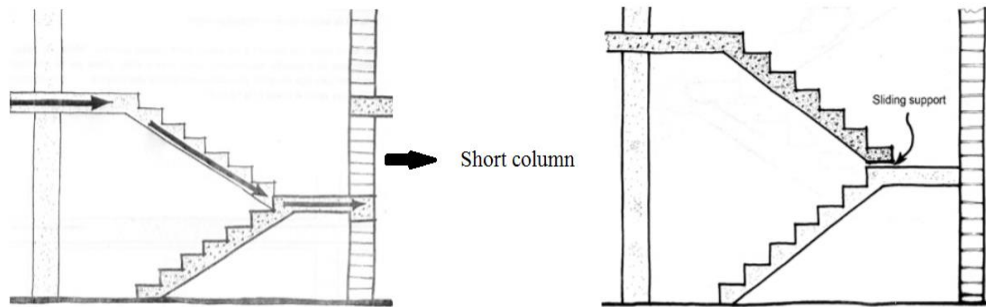
Figure 3.62 -From left to right: short column created by a stair landing and on the right, sliding support in the connection between the two stringers

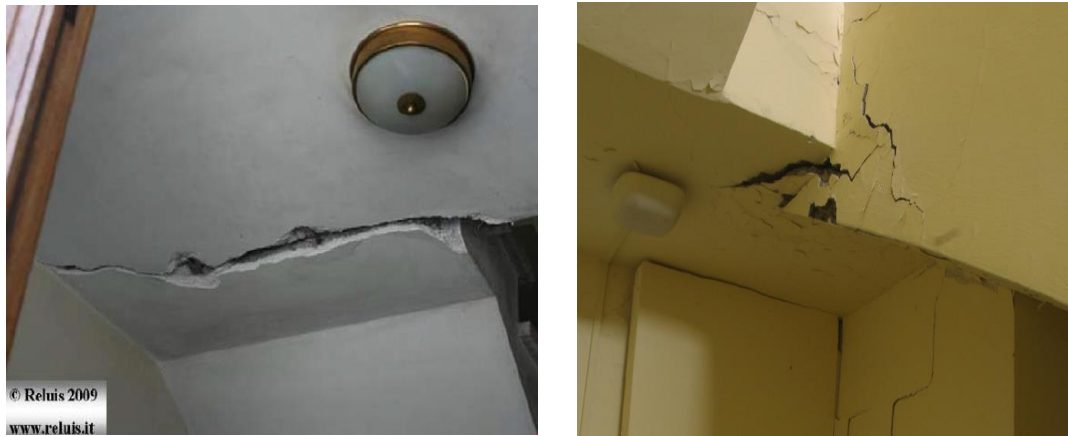
Figure 3.63 -From left to right: in this case is visible a large crack between the half pace and the last step. The stairs typology is clearly cantilever steps, Italy 2009. On the right, there is also a deep crack in the connection between the landing and the stringer probably due to lack of reinforcement detailing, Arquata del Tronto

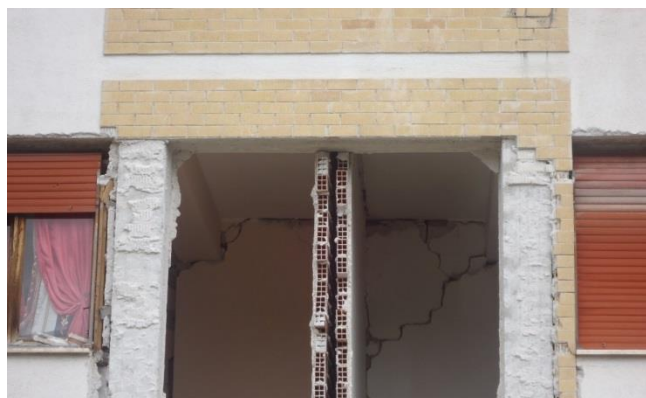
Figure 3.69 -In this image is possible to see all the damage aforementioned: in plane failure (diagonal crack), out of plane failure (incipient external leaf's overturning, infill walls' overturning and coatings' overturning), Norcia

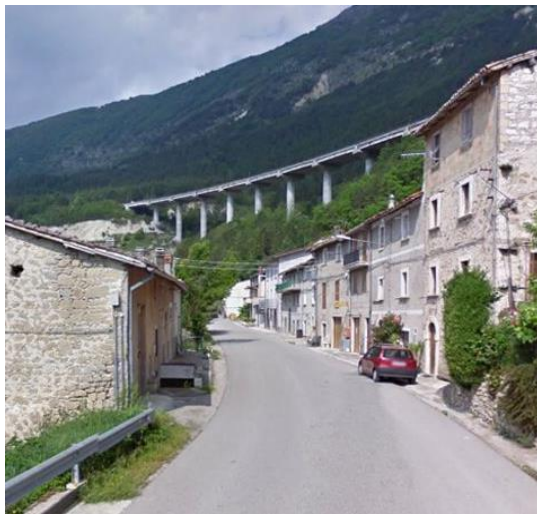
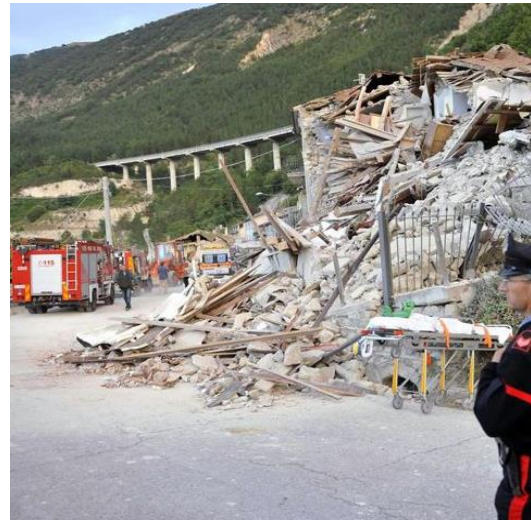
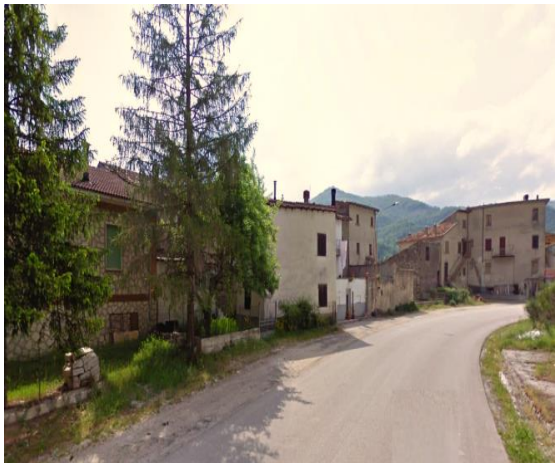
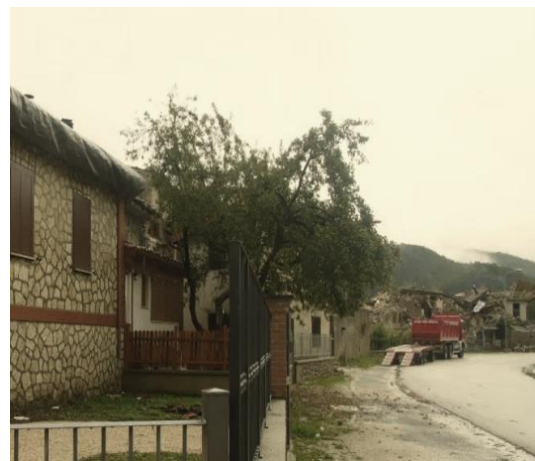
Regarding the earthquake of 24th August, many buildings in a row were completely devastated in the several villages. The figure represents two examples of full ruin of entire rows along the road accessing Pescara del Tronto. It is not possible to evaluate the causes of collapse only based on photographic inspection due to the high level of destruction. What is possible to guess is that the buildings “interacted” during the earthquake and toppled like “dominoes”, even those which would have resisted the event were taken down by the others. Important to mention that, buildings constructed during diverse periods and with diverse materials behave differently.

Figure 3.74 -Destruction of two entire rows of buildings in Pescara del Tronto

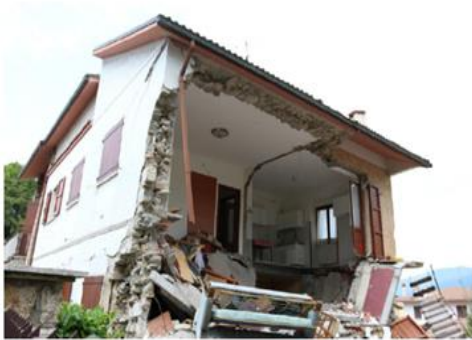
Image	Damage Level	Damage description
P1	D4	Collapse of both floor and façade in a masonry building
P2	D5	Full collapse of a masonry building with RC roof
P3	D4	Partial collapse of the masonry part of the school Romolo Capranica
P4	D2	Satisfactory behaviour of the RC part in school, only suffering non-structural damage
P5	D3	Severe in plane shear failure, X-cracking, in the police station
P6	D2	Non-structural damage in a RC building, out of plane of the infills
P7	D2	Non-structural damage, detachment of the plaster in the masonry building
P8	D3	Hospital, severe non-structural damage in the RC part (8a) and extensive in plane shear failure in the masonry part with incipient out of plane failure (8b)
P9	D5	Hammering of the RC roof in the masonry walls
P10	D5	Full collapse of a masonry building
P11	D1	Minor non-structural damage
P12	D2	Non-structural damage, separation of the infills from the RC frame

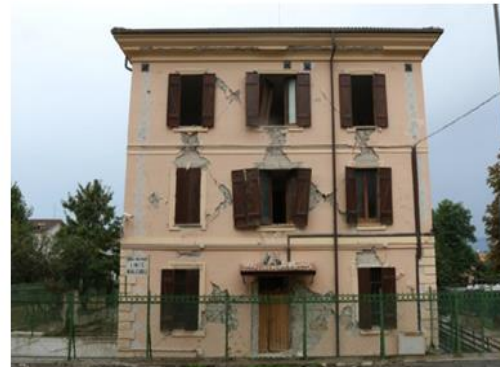
P5

The police station building, P5, is a masonry building that did not collapsed but suffered many in plane damage (shear cracking in both pier and spandrel panel). With a closer look is possible to visualize the steel ties close to connection between the roof and the walls hence, seems reasonable to state that this was a case of positive retrofitting and the building "behaved like a box". The images P3 belong to the same building, the school Romolo Capranica that, despite previous seismic interventions (only a five years ago) did not survived the August earthquake. This building was composed by both masonry and reinforced concrete corps and, as it is visible in the images, the masonry part collapse while the reinforced concrete part remained standing with non-structural damage. The hospital F. Grifoni, P8, was

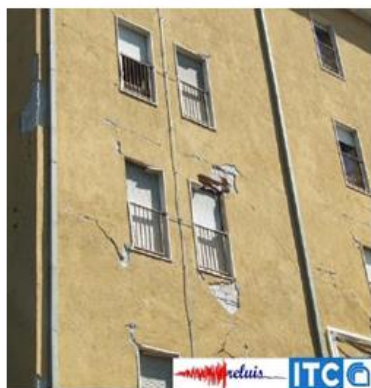
P8a

also composed by portions of masonry and reinforced concrete and, in this case, the response of the buildings was better than in other cases, although considerable damage to both structural and non-structural components were reported. The masonry part exhibited extensively in plane shear failure in both pier and spandrel panels and, in the worst case, below presented, one wall presents signs of an incipient out of plane mechanism. The reinforced concrete part exhibits diagonal cracking and separation between infills and structural frame accompanied by coatings detachment.

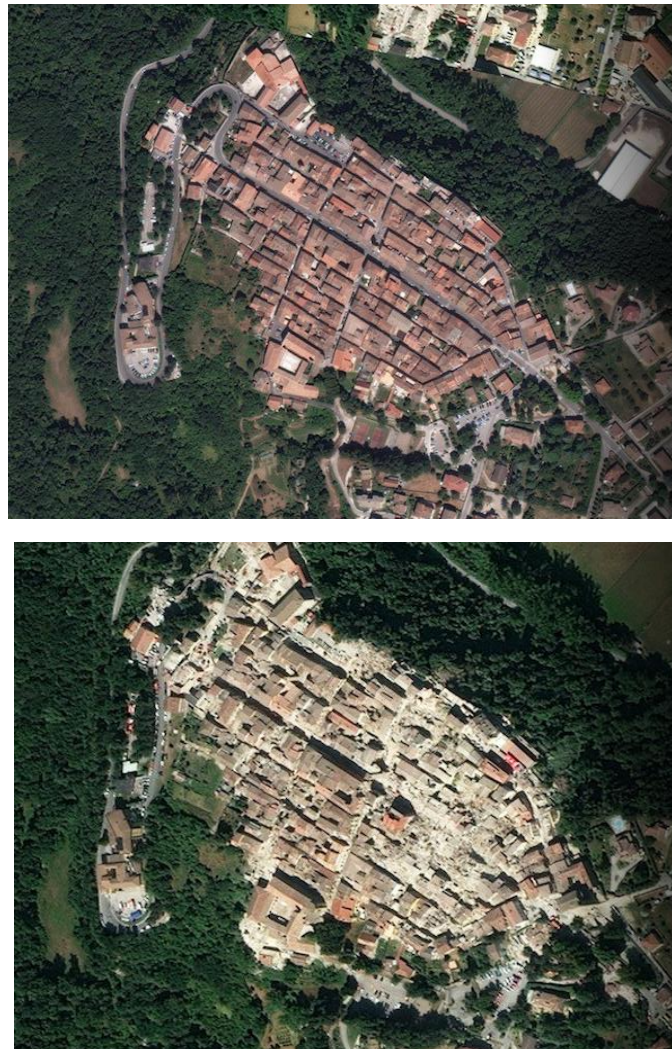
Figure 4.7 -Before the earthquake on top and after the earthquake on the bottom. The level of destruction is easily visible especially in the east zone

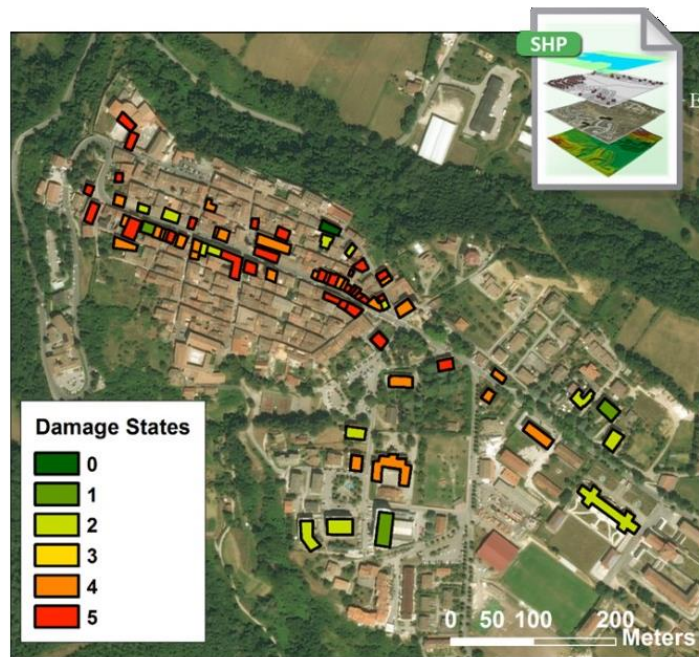
Figure 4.8--Overview of the damages in Amatrice seen by aerial image (source GEER)

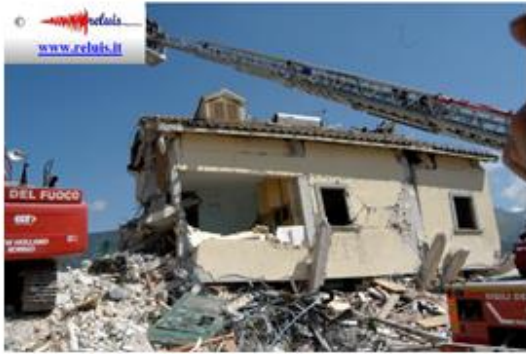
Image	Damage level	Damage description
P1	D5	Soft storey in Hotel Roma
P2	D2	Severe non- structural damage in a steel frame and incipient buckling of the columns
P3	D1	No visible damage
P4	D1	No visible damage
P5	D5	Partial collapse of a masonry building
P6	D5	Full collapse of a building with RC roof
P7	D2	Severe non-structural damage to a RC building
P8	D5	Full collapse of masonry buildings
P9	D4	Full collapse of masonry buildings
P10	D5	Full collapse of masonry buildings

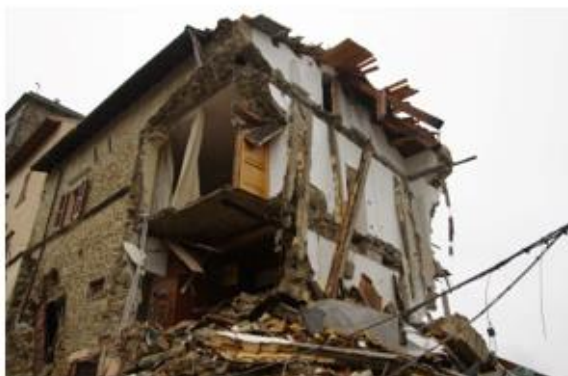
Image	Damage level	Damage description
P1	D4	Partial collapse of a masonry building
P2	D2	Non-structural damage including detachment of the plaster and incipient out of plane-vertical crack along the intersection
P3	D2	Severe non-structural damage in pier panels to a masonry building
P4	D5	Full collapse of masonry buildings
P5	D5	Full collapse of a masonry building with RC roof
P6		Collapse of a retaining wall
P7	D4	Out of plane mechanism of the front façade involving two floors
P8	D3	Panoramic view, masonry buildings with significant structural damage
P9	D5	Panoramic view, masonry buildings with significant structural damage
P10	D3	Severe cracks along the intersections that may trigger out of plane mechanisms
P11	D1	Minor non-structural damage
P12	D1	Minor non-structural damage
P13	D4	Partial collapse of a masonry building

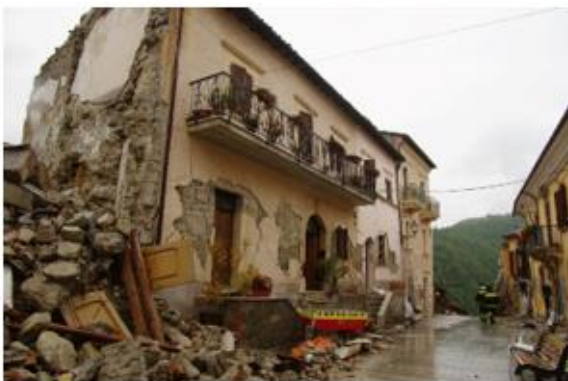
P3

In case of picture P5, the structure exhibited a heavy concrete roof that led to its collapse. The adjacent building (picture P3) behaved completely different only suffering in plane shear failure with detachment of plaster in the pier panels. Cases of total and partial collapse (pictures P1, P4, P7 and P13) occurred but also many masonry buildings behaved well during the event (pictures P2, P3, P11 and P12). Cases of failure of retaining walls were also reported (picture P6) along the road accessing Arquata.
